# Phones do not work (page 1 of 3)

# Noise on the lines (page 1 of 1)

# Hum on the lines (page 1 of 2)

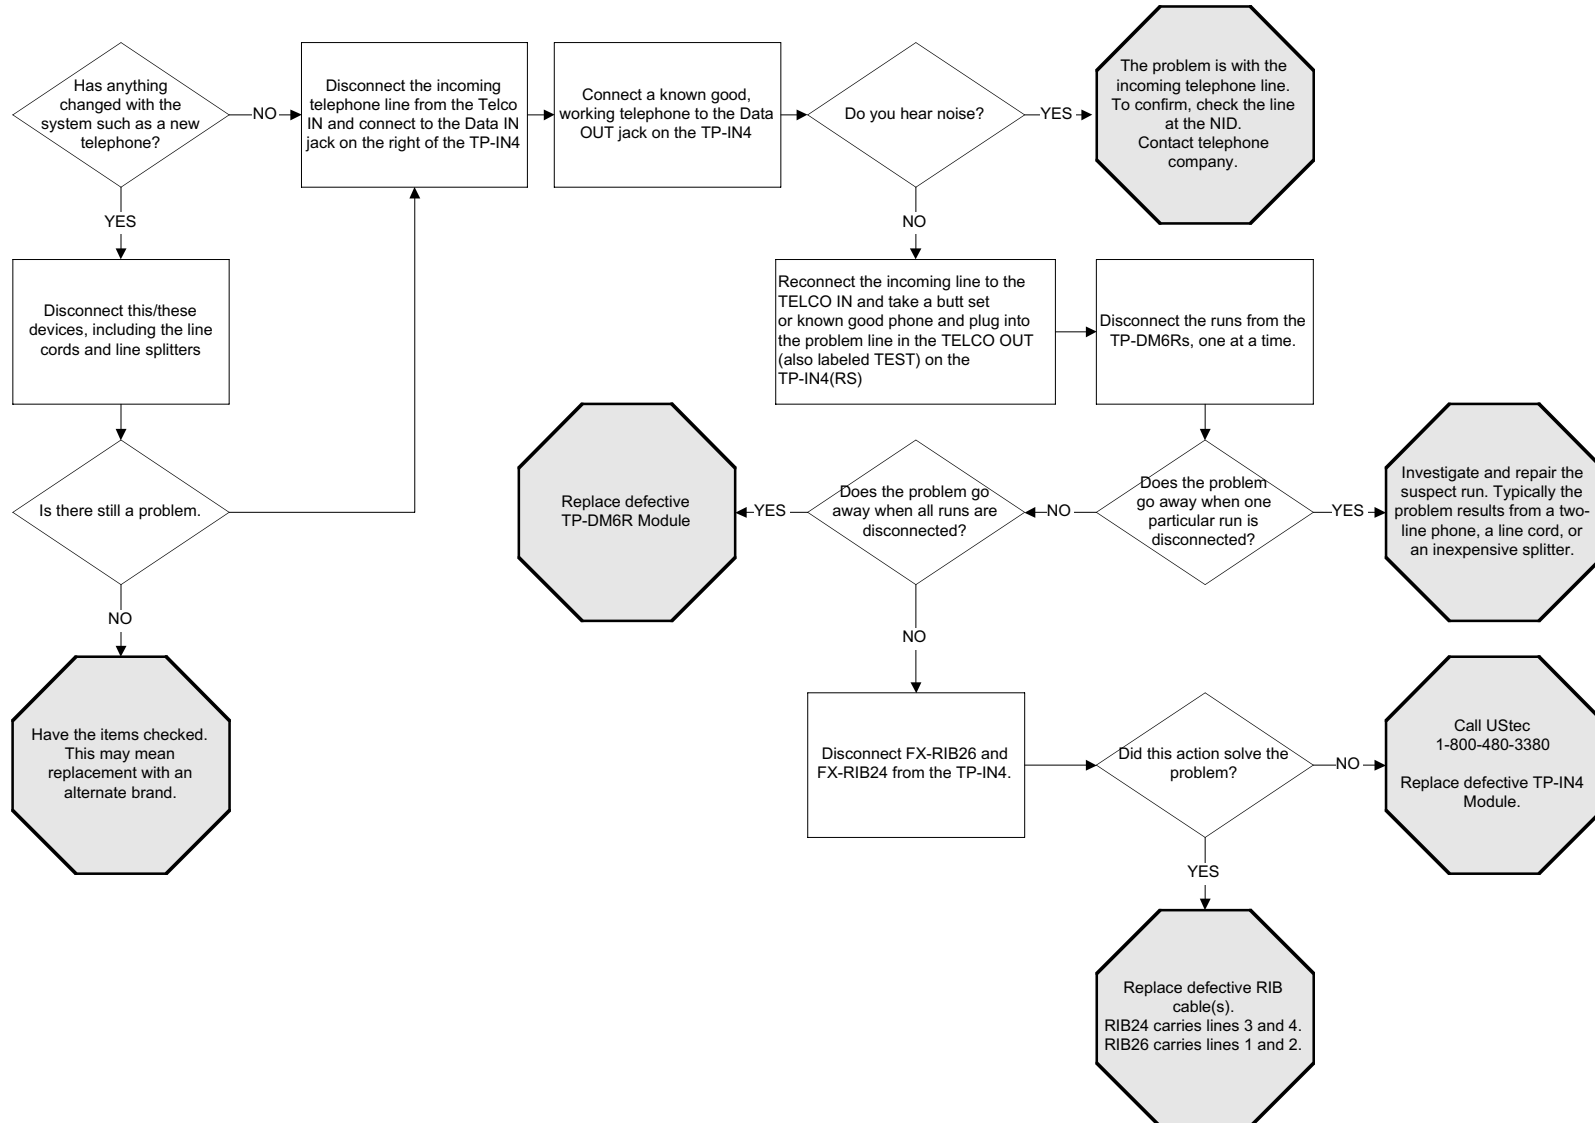
This troubleshooter will help you pinpoint noise problems such as crosstalk. Crosstalk, in this instance, has to do with the fact that you can hear line A on line B.

By far the most common cause of crosstalk and associated noises are two-line phones and inexpensive line splitters. A POTS (plain old telephone) network is only as good as its weakest link because everything is wired in parallel. Once one bad device is plugged in, its problems will be noted everywhere.

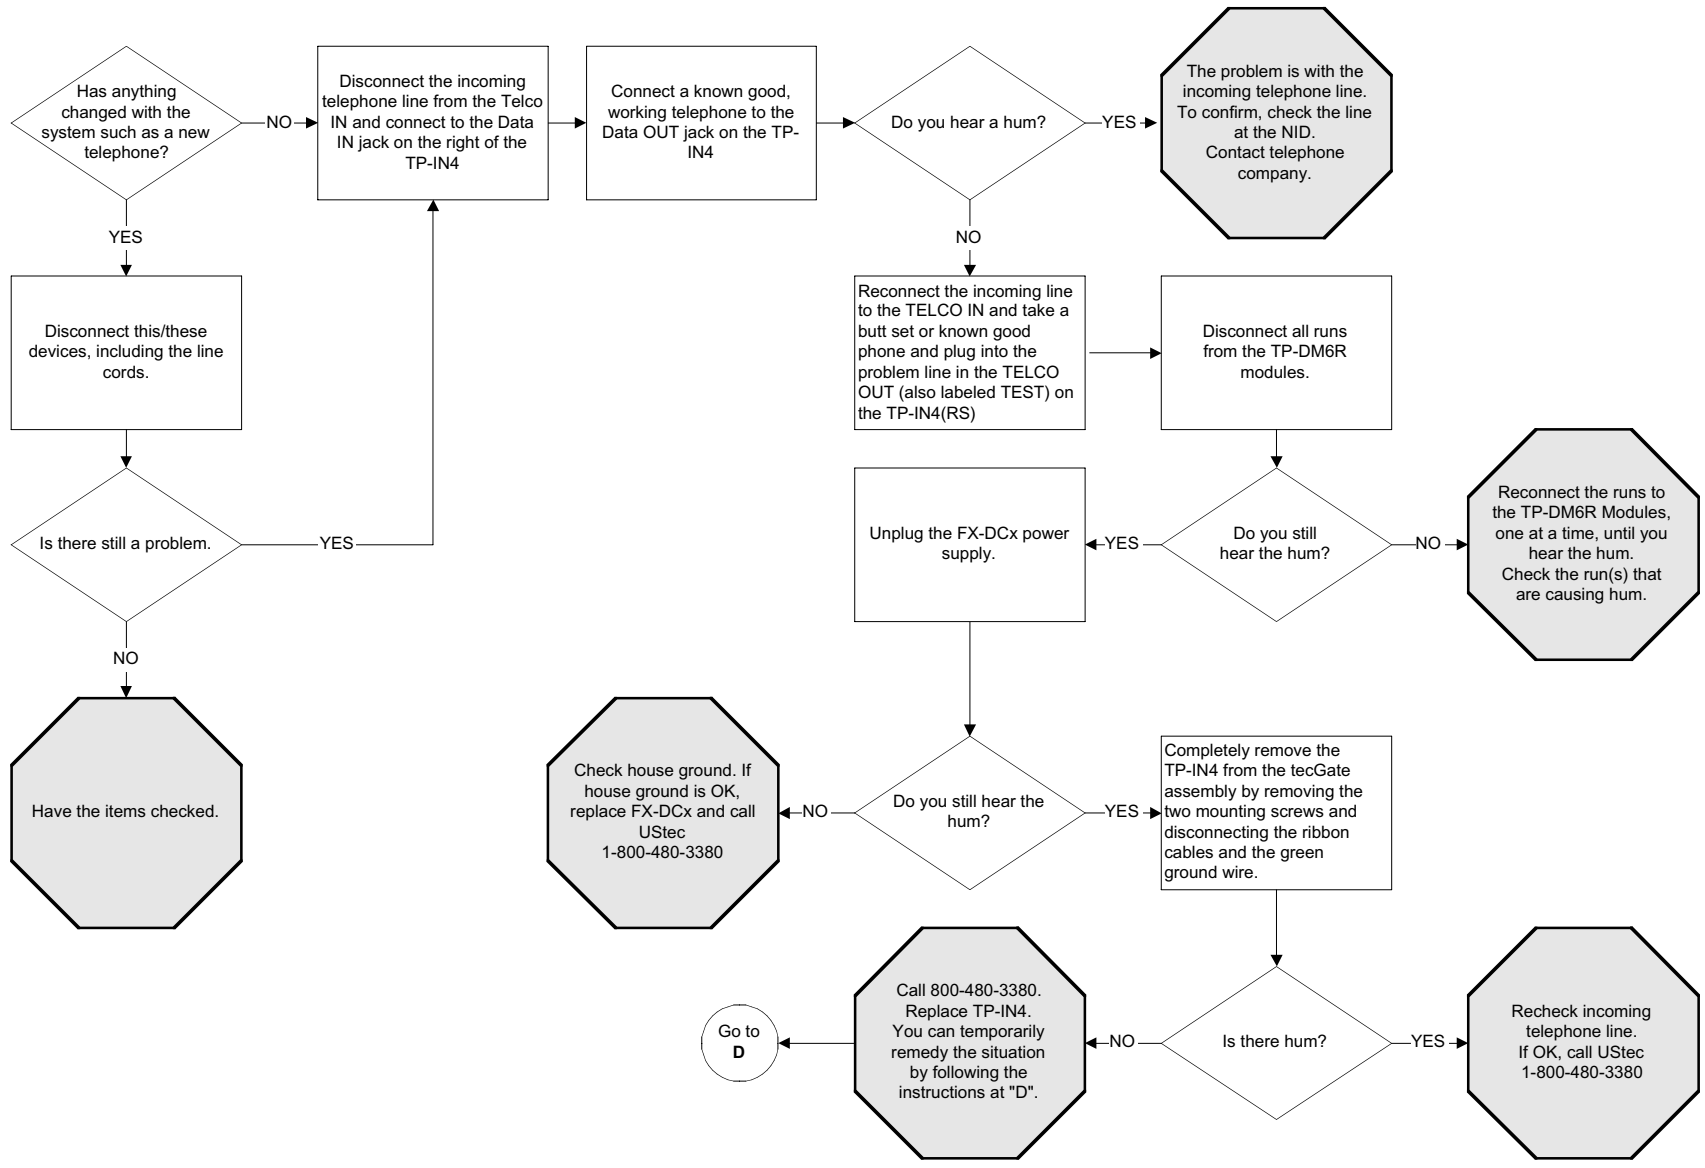
Hum is caused by an impedance mismatch. This is occurring in the TP-IN4's surge function. Each of the eight conductors is protected with a National Semiconductor Transorb and a 250V 3/4 AMP fuse (TP-IN4RS is a different design). The transorb is the culprit because it has taken repeated surges. This usually occurs when the telephone company is not correctly protecting its system.

You can test with a standard ohmmeter across the radial lead of the transorb (black unit on the back of the TP-IN4).

There should be infinite resistance on all the units. When they begin to fail, they actually leak to ground. This leak makes the phone line seem longer to the equipment connected to it. It is the difference between the Tip and Ring impedance that causes the hum. For example, if Tip on line 1 has infinite resistance, but the Ring read 2000 ohms resistance, this in effect makes the ring side of the line appear as though it were several hundred feet longer than the Tip inducing hum.

**Temporary remedy: snip the leads on the suspect transorbs (3/4 AMP glass fuse still provides protection as long as incoming telco goes through TELCO IN.**
